July 25, 2007

No. 2007- 03

Bechtel Communications, Inc. ES&H Alert

Incident: Two JLG 860SJ were discovered with sheared bolts in the swivel area of the JLG. The manufacturer and vendor have been contacted about the situation.

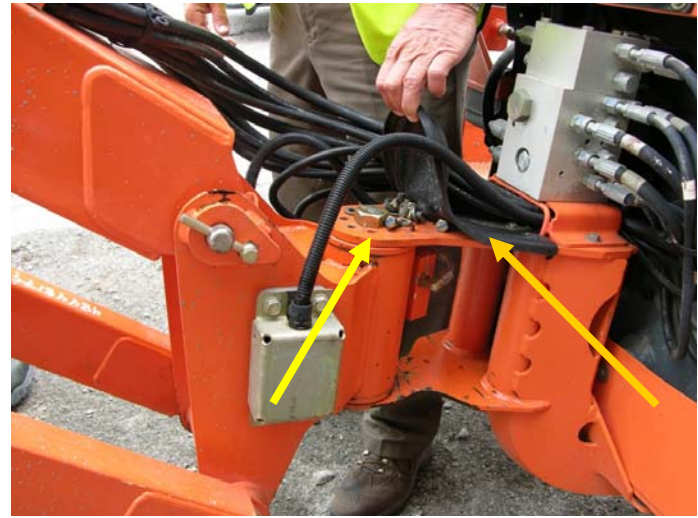
On a construction project in the northwest US, two JLG 860SJ were discovered with sheared bolts in the swivel area of the JLG. The bolts are concealed by a cover plate, making this difficult to discover during daily inspections. Both the vendor and manufacturer have been contacted to investigate the causal factor.

* Picture of cover plate and sheared bolts

1. Locate all 860SJ JLG's on your site or facility.
2. Have your maintenance personnel or vendor remove the cover plate and inspect in accordance with the manufacturer's maintenance manual to see the following:
 - a. Any sheared bolts
 - b. Corroded bolts
 - c. Any damage to the bolts
3. If the swivel bolts are damaged, remove your JLG from service.
4. Contact your vendor and/or the manufacturer to arrange replacement and proper maintenance.
5. If renting this model, have vendor remove cover plate and inspect bolts for damage.

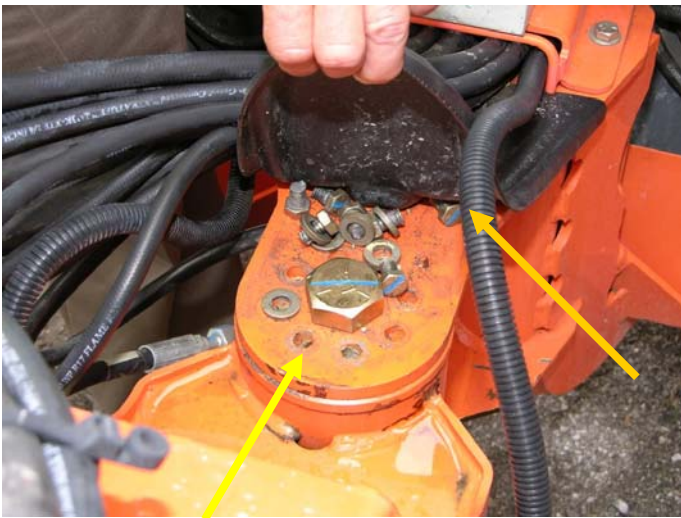
* Picture shows the sheared bolts under plate

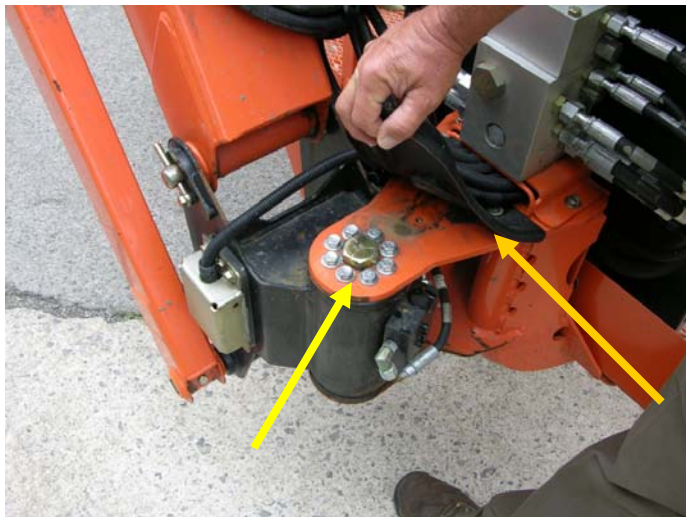
* Picture of replaced bolts in one of the units
