MANITOWOC SERVICE BULLETIN W08-010

DATE: 07-25-2008

SUBJECT: Model 16000 #58 boom sections, #59A mast sections and #59 Luffing jib sections

MODEL AFFECTED: 16000

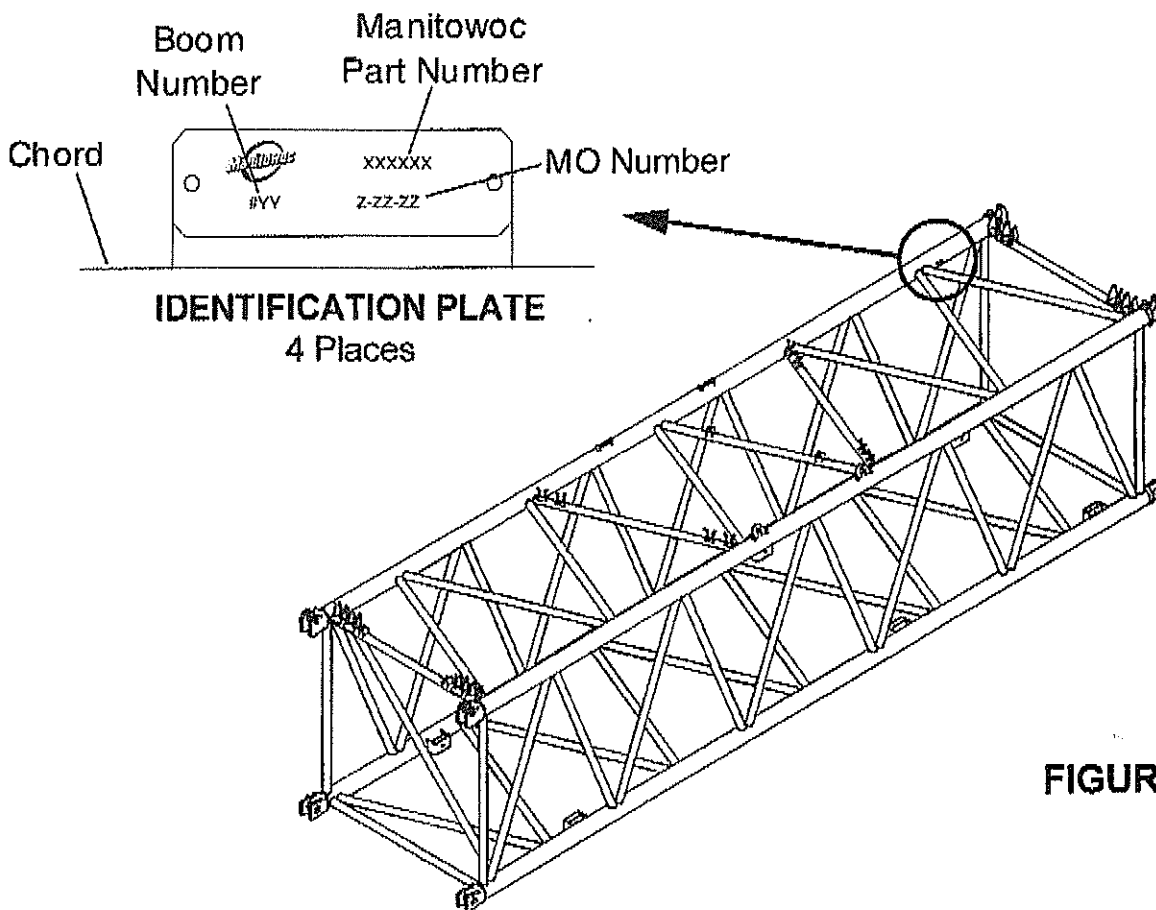
FIGURE 1

The weldments identified in the table below may have chords which do not comply with the specified wall thickness. The weldment part numbers appear on the identification tag on each boom, mast or jib section as shown in Figure 1 below. The corresponding section assembly numbers for these weldments are also provided for reference.

If a weldment part number matches one of those listed above, locate the manufacturing order (MO) number on the identification tag for the weldment as shown in Figure 1 and compare it to the MO numbers listed on the attached Inspection Report. If the MO numbers for any of the weldments match the MO numbers listed in the Inspection Report, ultrasonic test the weldment in accordance with Section A3 below. If you need assistance in locating ultrasonic test equipment or ultrasonic testers, please contact the Crane CARE Lattice Team at **1-888-499-7278** for further instructions.
