Ironworkers...On the Safe Side

Erecting Open Web Steel Joist: One of the Deadly Dozen Hazardous Activities

Ironworkers International
Washington, DC
March 7, 2012
Volume 3

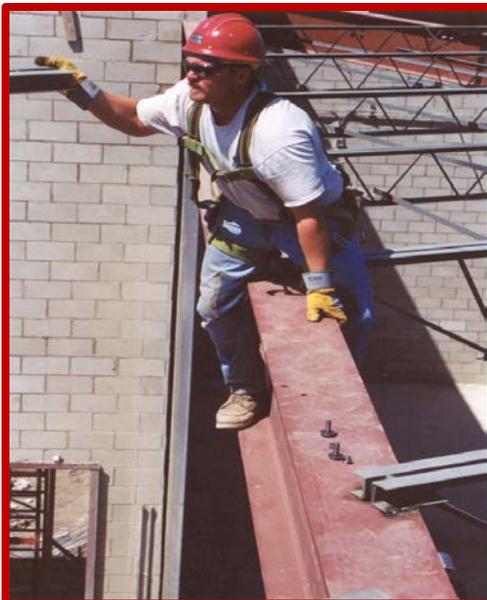
Requirements for Securing Joist Ends to Prevent Displacement Hazards – One of the primary causation factors in many serious incidents and fatalities has been

attributed to the failure to adequately secure the joist ends to the structure. When joists ends are not secured (bolted or welded) to the supporting beam or joist girder upon final placement, hazards pertaining to accidental displacement exists. Ironworkers traveling from point to point or dragging welding lead over the unsecured joists can easily cause the joist ends to slide, lose bearing and collapse to the ground or next lower level below.

OSHA 1926 757(b)(3)- “except when panels that have been pre-assembled from steel joists with bridging, each steel joist shall be attached to the support structure, at least at one end on both sides of the seat, immediately upon placement in the final erection position and before additional joists are placed.”

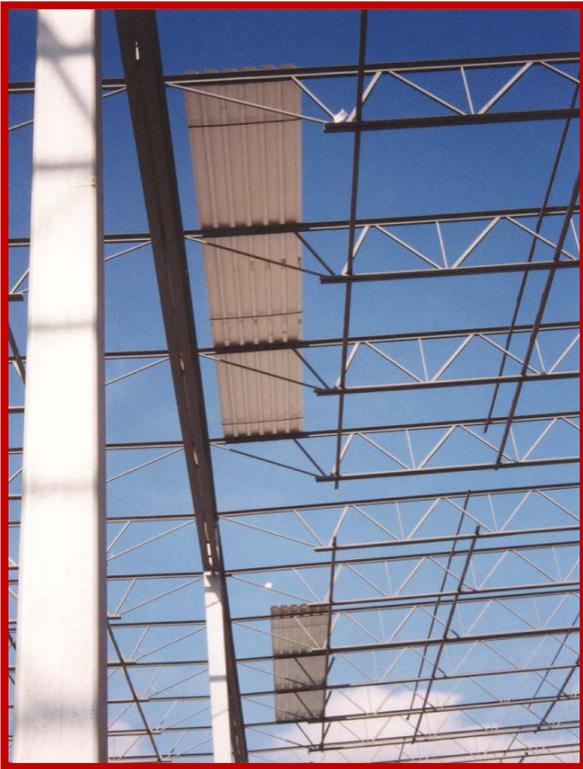
Requirements for Field-Bolted Joist Ends

Long joists that are erected in bays of 40 feet or more have a greater tendency to twist or rotate, and creates displacement and collapse hazards for the Ironworkers installing them. Requiring these joists to be field bolted at the time of final placement will allow the ironworkers to safely erect, plumb joists, and install diagonal bolted bridging or horizontal bridging. The following OSHA standard protects Ironworkers from the hazard of the joist ends losing bearing on the structural support.

This OSHA standard requires both the steel joist shoe and the beam to be fabricated with holes to allow for field bolting.

The OSHA 1926 757(a)(8) requires “(i) except for steel joists that have been pre-assembled into panels, connections of individual steel joists to steel structures in bays of 40 feet or more shall be fabricated to allow for field bolting during erection. (ii) These connections shall be field-bolted unless constructability does not allow.”

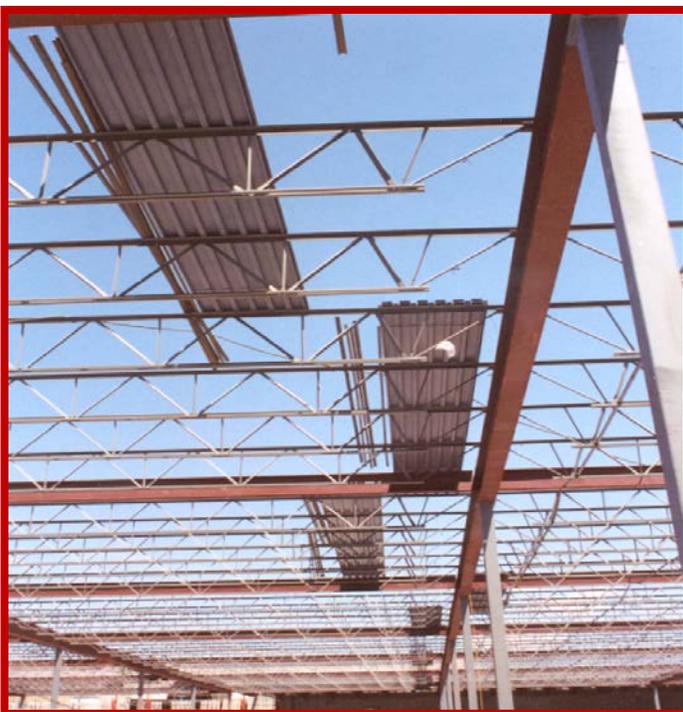
Requirements for Landing Deck Bundles to Prevent Structural Collapse Hazards

Landing bundles of metal decking or bundles of horizontal bridging on steel joists that have not been adequately secured has caused many fatalities and structural collapse incidents. Bundles of joist bridging must be limited to 1000 pounds and placed within one foot of the secured end. These hazards are addressed by the following OSHA standards.

1926.757(e)(2) – “Except for special conditions contained in 1926.757(e)(4), no construction loads are allowed on the steel joists until all bridging is installed and anchored and all joist-bearing ends are attached. 1926.757(e)(5) – The edge of the construction load shall be placed within 1 foot of the bearing surface of the joist end.”

1. The employer has first determined from a qualified person and documented in a site-specific erection plan that the structure or portion of the structure is capable of supporting the load;
2. The bundle of decking is placed on a minimum of 3 steel joists;
3. The joist supporting the decking are attached at both ends;
4. At least one row of bridging is installed and anchored;
5. The total weight of the bundle of decking does not exceed 4,000 pounds; and
6. Placement of the bundle of decking shall be in accordance with paragraph (e)(5) of 1926.757.

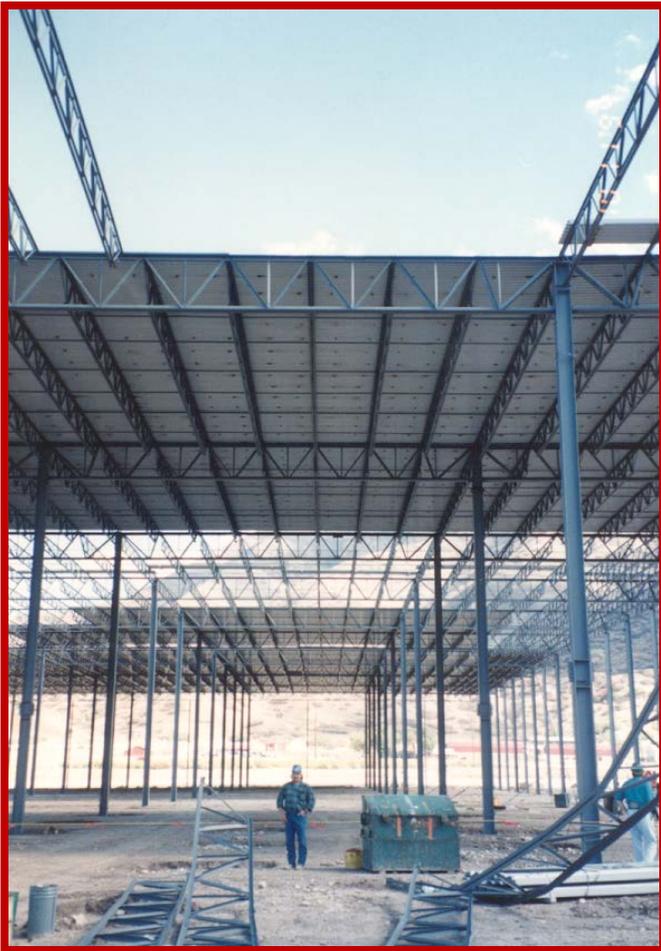
Examples of Hazards and Unsafe Joist Erection

The photograph on the left illustrates several serious hazards and OSHA violations. The steel joists were loaded with bundles of metal roof decking and horizontal bridging prior to the joist ends being secured and bridging installed. Additionally, the decking bundles were not placed within 1 foot of the bearing surface of the joist end. This can cause the unsecured joist to either shift or sprawl under loading. This jobsite was a fast-track project where many Ironworkers were accessing unsecured joists and shaking-out horizontal bridging. Serious accidents involving structural collapse can occur if the open web steel joists are not adequately secured prior to landing deck bundles, bridging bundles, or other construction materials. Ironworkers must never access joists unless all the above conditions are met.
