May 19th, 2017

# IMPORTANT - STOP USE AND INSPECT - POTENTIAL CABLE FRAYING / BIRD-CAGING - HALO & EDGE CABLE SELF-RETRACTING LIFELINES (SRLs)

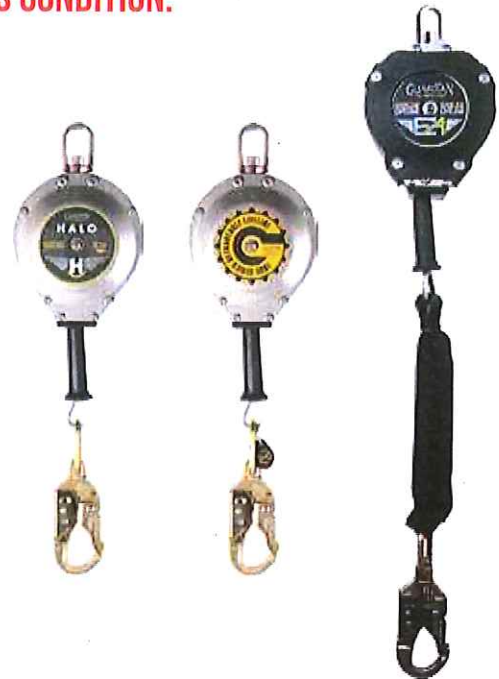
Identify the SRL part # and date of manufacture, which are located on the back SRL label. If the SRL part # is included in this notice, and if the date of manufacture is from January 1st, 2015 through March, 2017, immediately remove the product from service and inspect as specified by this notice.

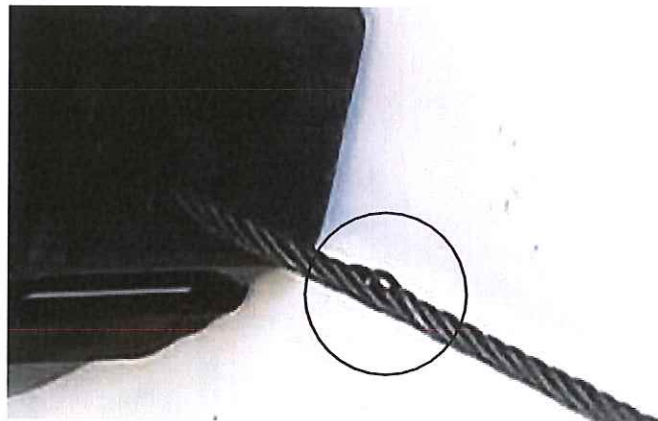
**EXAMPLES OF LIFELINE DAMAGE:**

**Cable fraying at swage contact point**

**(Swage may be located beneath rubber stopper)**

**Bird-caging**

If SRL shows any signs of cable fraying or bird-caging, immediately remove unit from service and contact Guardian Fall Protection regarding its repair. See Step 3.

All affected units will be repaired, recertified, and returned to the customer by Guardian free of charge (including all shipping costs). Customer Service will provide instructions for shipping returned product on Guardian's shipping account.

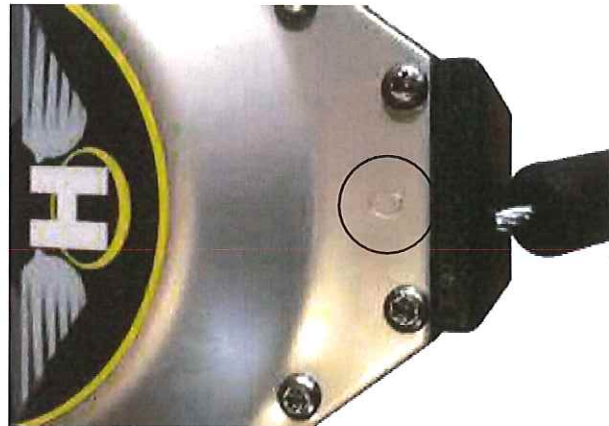
**Repaired SRLs will be stamped with a "C" to indicate they have been repaired and the unit can be returned to service.**
