DATE: 25 June 2009**SUBJECTS:** Miller Back Biter lanyards

Backbiter rivet issue

Subject: Miller BackBiter Shock-Absorbing Lanyard Model No. 8798B

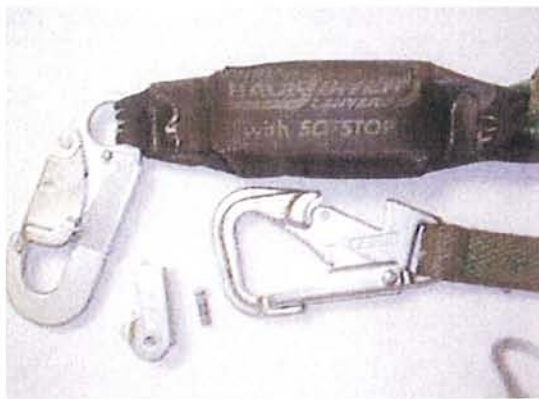
Miller Back Biter lanyard being used by employee at time of failure. Date of manufacturer of this particular lanyard is 05/09/08. In service date of this lanyard was 02/17/09.

Action Needed: There was an identical incident in October of 2008 at another facility (same manufacturer, same model and same failure). If you are currently using Miller Back Biter lanyards (either single or double legged), an immediate inspection by a competent person is needed. If there is any question to the integrity of a lanyard, remove it from service and contact your supervisor or a contractor safety professional on a path forward. Additionally, your company should evaluate whether to continue to utilize this lanyard.

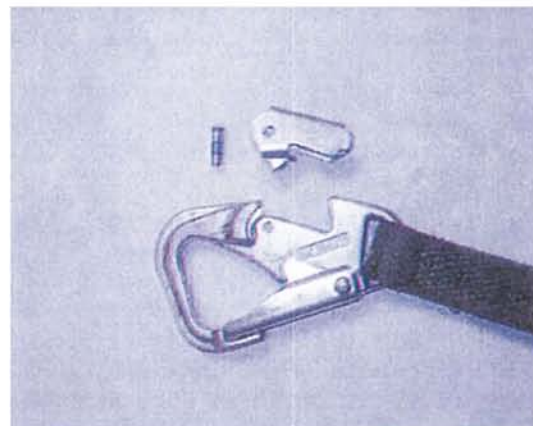
The detached locking keeper and the rivet that held the keeper in place. Upon inspection, neither appear to show signs of damage or abuse. The head of the rivet appears to be cleanly sheared off.

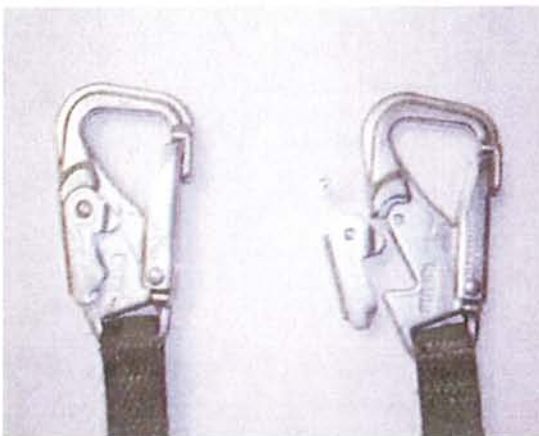
Side by side comparison of the two snap hooks on the lanyard that failed. Neither snap hook appears to show any signs of damage or abuse. A better look at the clean shear of the rivet holding the locking keeper to the snap hook.

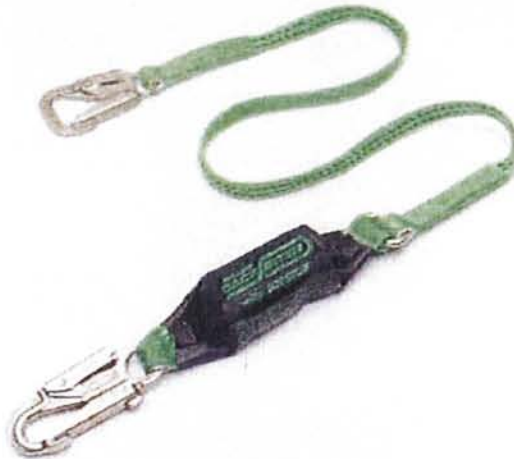
Background: We were notified of a backbiter rivet shearing, causing the keeper on the snap hook to detach from the unit. Note: The snap hook and gate were still intact. With the keeper becoming unattached, this resulted in the loss of dual-action functionality of the snap hook. The lanyard and snap hook were drop tested at our facility and passed all applicable ANSI testing. Rivet was analyzed and was to specification metallurgically.

Corrective action: A letter was published to our customers explaining the situation. We were not able to duplicate the failure in our test lab. From the analysis we performed, we concluded that the rivet pin, if repeatedly struck, drug across rough surfaces, and abused, could possibly cause the rivet pin to shear. (We had no test data to prove, but we did have two instances in the field). We instructed our customers to carefully inspect the rivet heads for signs of wear prior to use.

Preventative action: Immediately, we switched to a different design which shielded the rivet pin from damage, Note the countersunk rivet head. This countersunk design protects the pin from accidental blows and wear over time.
